TRADITIONAL RESERVE STUDY STRUCTURAL INTEGRITY RESERVE STUDY

Naples Square III
1135 Third Avenue South
Naples, Florida 34102

Project Number 2407990

July 12, 2024

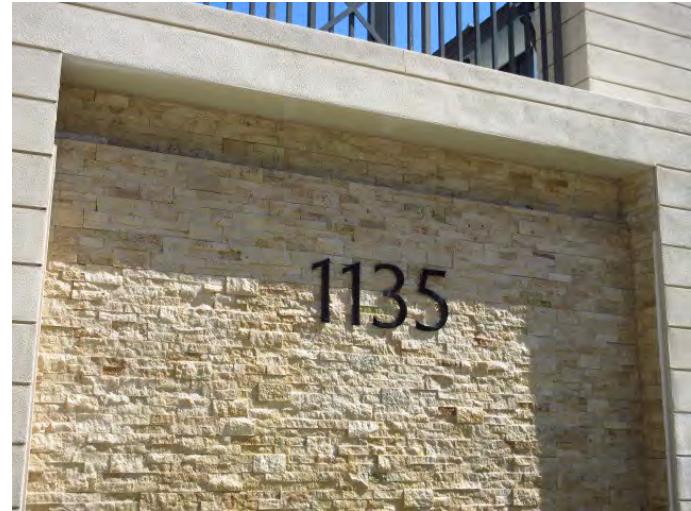
PHOTO 1

PROPERTY IDENTIFICATION SIGN

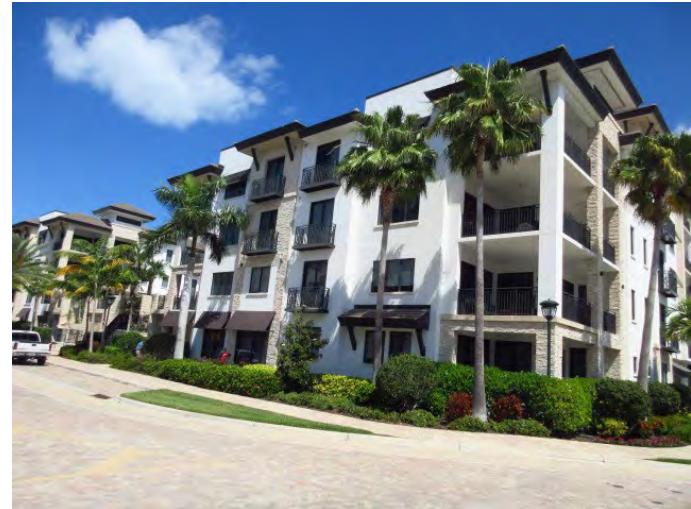
PHOTO 2

GENERAL VIEW OF PROPERTY

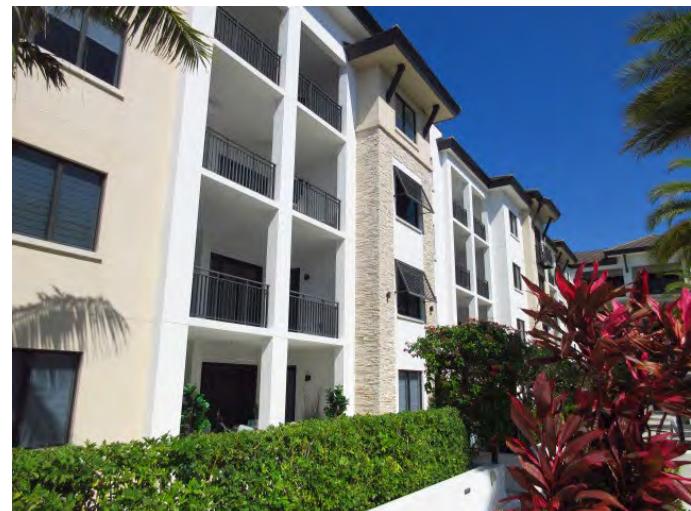
PHOTO 3

GENERAL VIEW OF PROPERTY

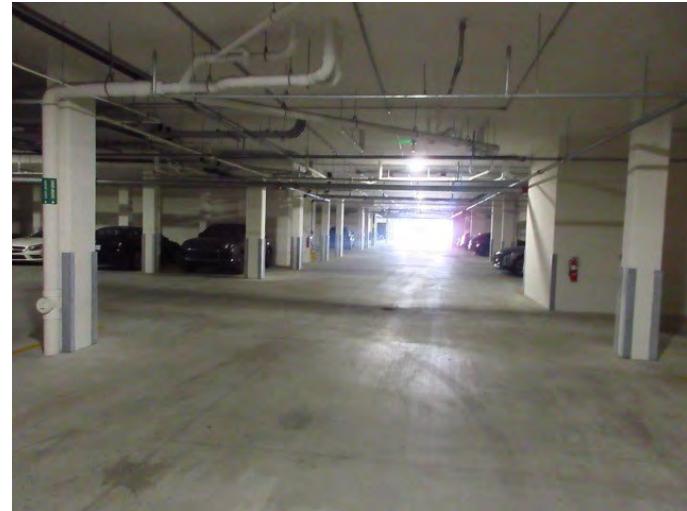
PHOTO 4

Parking/Paving	<p>Vehicular access to the Property is via motorized gates. Parking is provided in a tucked-under garage.</p> <p>The parking and driveway areas were noted to be in good condition, requiring routine maintenance over the evaluation period.</p>
Sidewalks	<p>Property pedestrian walkways and flatwork consist of a combination of concrete and pavers.</p> <p>The sidewalks appeared to be in good condition, requiring routine maintenance over the evaluation period.</p>
Exterior Lighting	<p>Site lighting is provided by pole- and building-mounted fixtures.</p> <p>Site lighting was noted to be in good condition. Based on the EUL of 25 years, funds for have replacement been spread throughout Replacement Reserves Cost Estimate Table, adopting the straight-line accounting method to ensure the availability of funds at the end of the replaced element's EUL, beyond the evaluation period of this assessment.</p>

GENERAL VIEW OF PARKING GARAGE

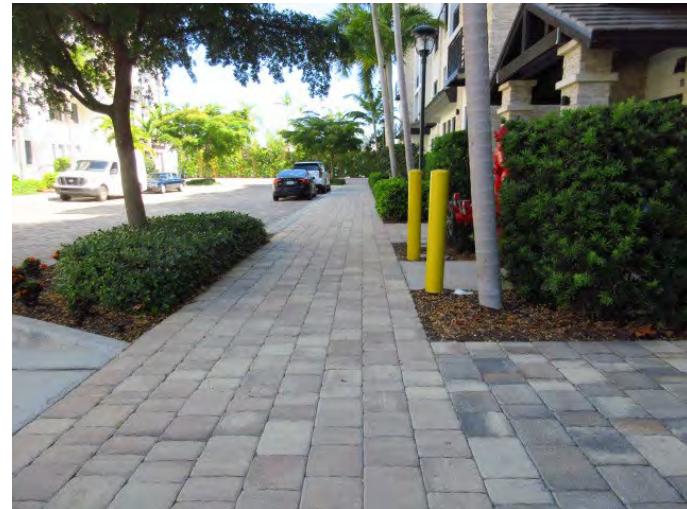
PHOTO 5

GENERAL VIEW OF PEDESTRIAN WALKWAY

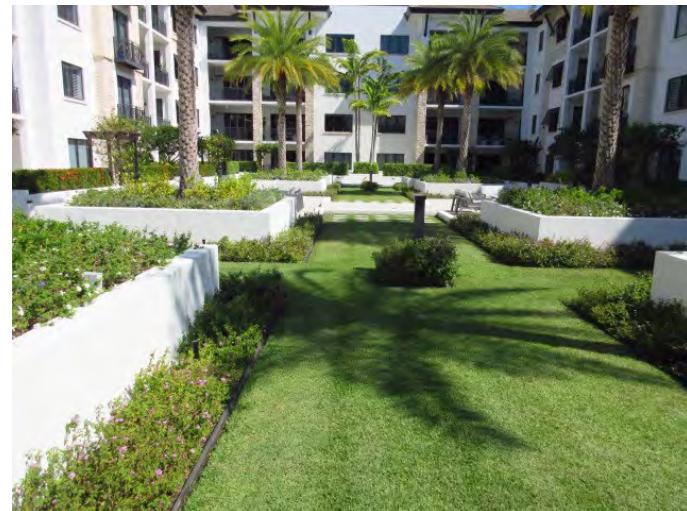
PHOTO 6

VIEW OF RECREATION COURT

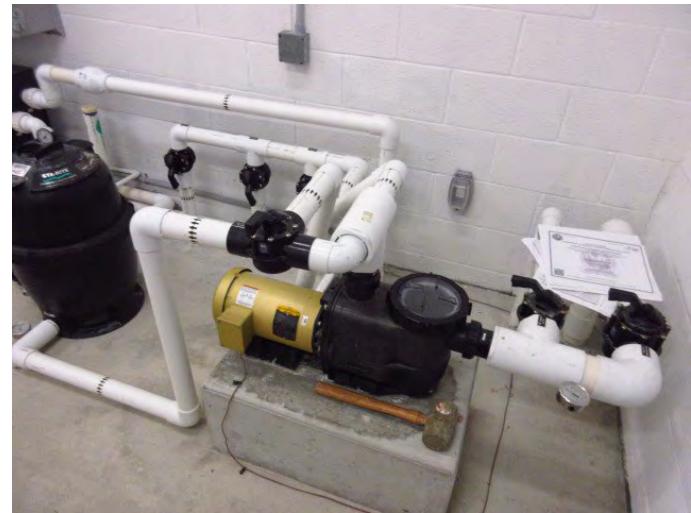
PHOTO 7

Item	Description/Observations/Comments
Swimming Pool	<p>The Property has one in-ground outdoor swimming pool. The swimming pool is constructed of concrete, with concrete coping, and pavers walking surfaces surrounding the pool.</p> <p>The swimming pool surfaces were noted to be in generally good condition. Based on the EUL of 15 years, resurfacing should be anticipated during the evaluation period. Funds have been spread throughout Replacement Reserves Cost Estimate Table, adopting the straight-line accounting method to ensure the availability of funds at the end of the replaced element's EUL, beyond the evaluation period of this assessment.</p>
Pool Equipment	<p>The swimming pool equipment consists of a heater, water filter and circulating pump.</p> <p>The swimming pool equipment was noted to be in good operating condition. Based on the EUL of 10 years, replacement of the swimming pool equipment should be anticipated during the evaluation period. Funds have been spread throughout Replacement Reserves Cost Estimate Table, adopting the straight-line accounting method to ensure the availability of funds at the end of the replaced element's EUL, beyond the evaluation period of this assessment.</p>

GENERAL VIEW OF SWIMMING POOL EQUIPMENT

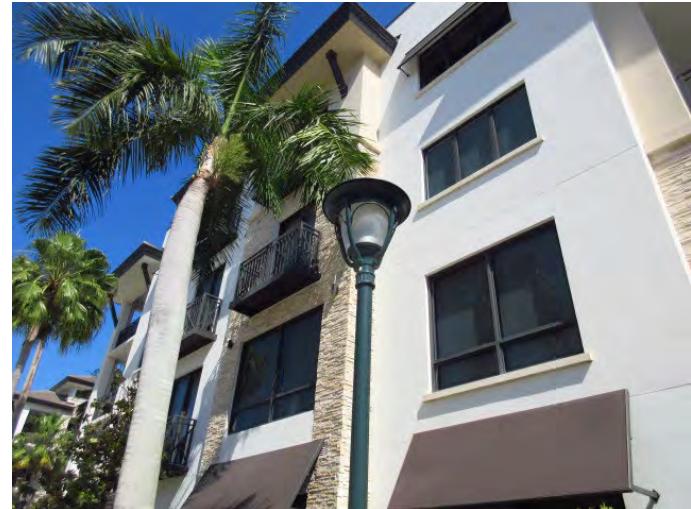
PHOTO 8

VIEW OF SITE LIGHTING

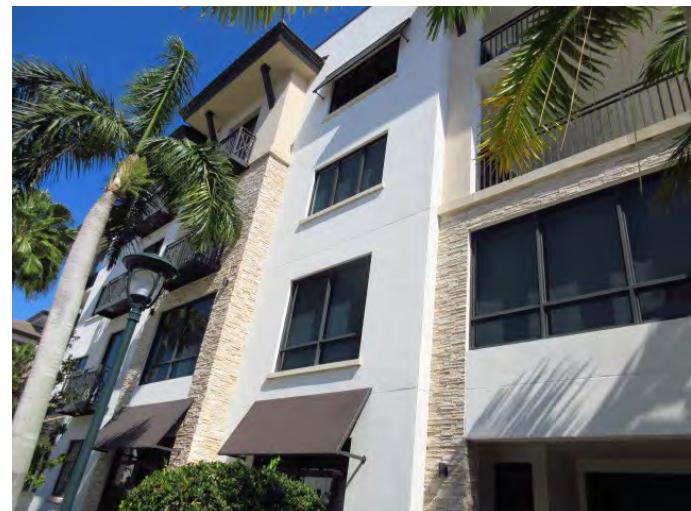
PHOTO 9

Exterior Walls	<p>The exterior walls typically consist of concrete masonry unit (CMU) construction finished with painted stucco.</p> <p>The exterior walls were noted to be in generally good condition, with no significant deficiencies noted.</p> <p>Based on the EUL of 10 years, repainting, waterproofing and periodic stucco restoration of the exterior surfaces are anticipated during the evaluation period. Funds have been spread throughout the Replacement Reserves Cost Estimate Table, adopting the straight-line accounting method to ensure the availability of funds at the end of the replaced element's EUL, beyond the evaluation period of this assessment.</p> <p>Please note that the extent of the exterior walls' evaluation did not include sampling or testing, therefore comments made regarding the condition of the façade components are limited to visual observation. Should a more comprehensive investigation be required, further assessment that includes destructive to determine the extent of the deficiencies is recommended.</p>

VIEW OF BUILDING EXTERIOR FINISHES

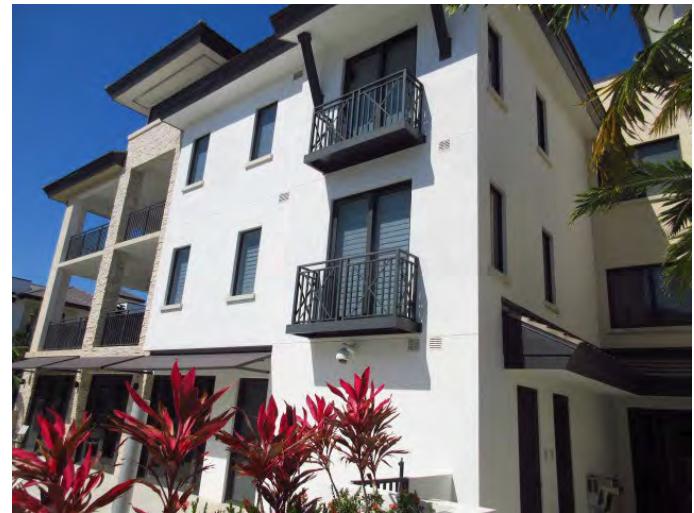
PHOTO 10

GENERAL VIEW OF BUILDING EXTERIOR FINISHES

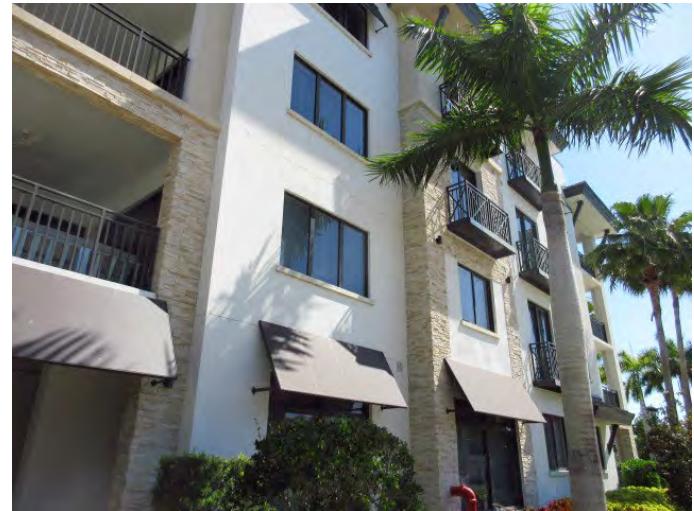
PHOTO 11

GENERAL VIEW OF BUILDING EXTERIOR FINISHES

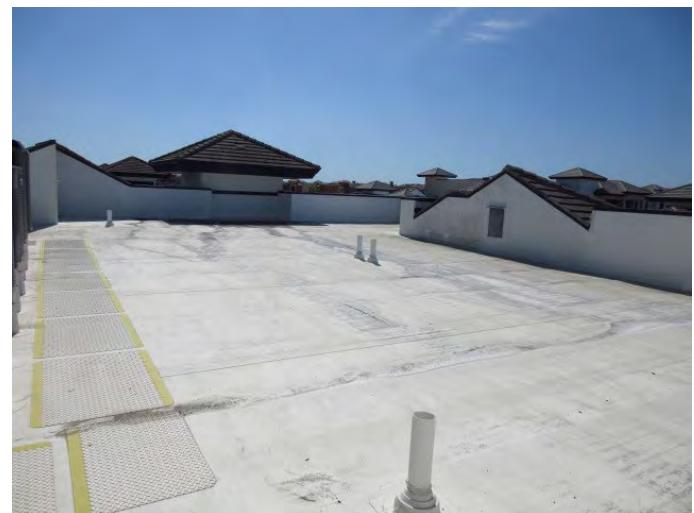
PHOTO 12

Roof	<p>The roof coverings consist of a combination of a low-slope system (flat) TPO membrane, and a pitched concrete tile system.</p> <p>The roof coverings were noted to be in good condition. Based on the EUL of 20 years for TPO membrane and 40 years for concrete tile systems, funds for replacement have been spread throughout the Replacement Reserves Cost Estimate Table, adopting the straight-line accounting method to ensure the availability of funds at the end of the replaced element's EUL, beyond the evaluation period of this assessment.</p>

VIEW OF ROOF COVERING

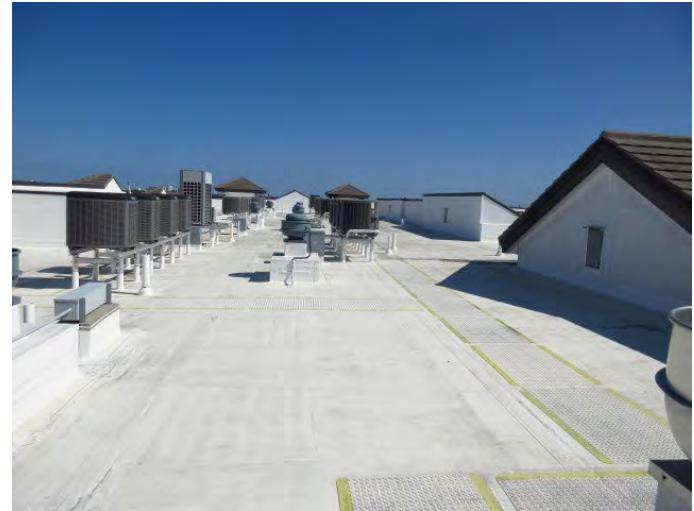
PHOTO 13

VIEW OF ROOF COVERING

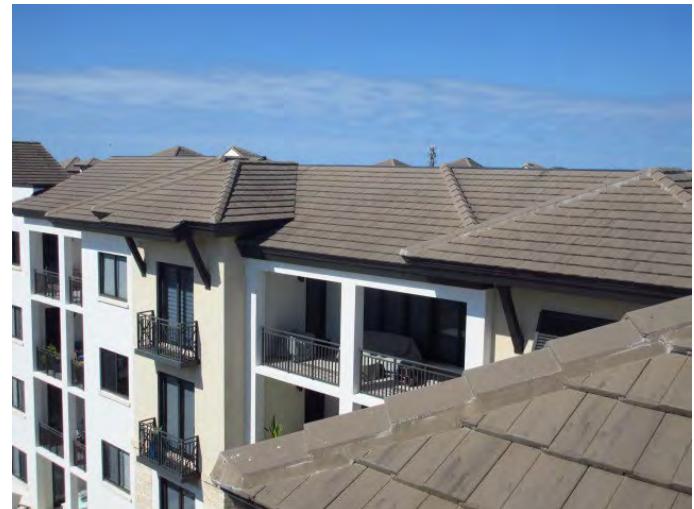
PHOTO 14

VIEW OF ROOF COVERING

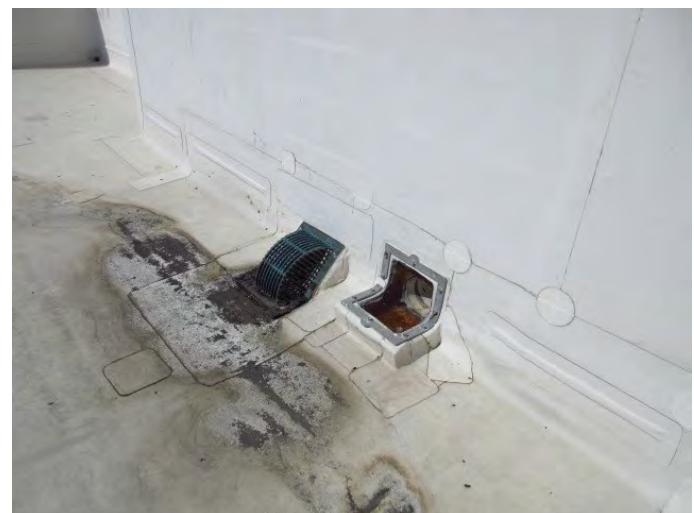
PHOTO 15

GENERAL VIEW OF ROOF DRAIN

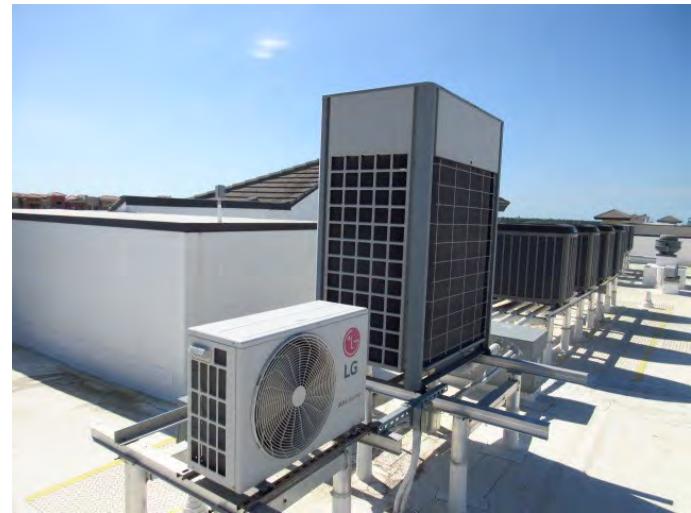
PHOTO 16

Item	Description/Observations/Comments
HVAC	<p>Cooling and heating are supplied by individual electric forced-air furnaces with split-system air-conditioning condensing units. There are multiple units serving the common areas.</p> <p>HVAC at the dwelling units is the responsibility of the condominium owners to maintain and replace.</p> <p>Replacement of the common area units is anticipated during the evaluation period. Funds have been spread throughout the Replacement Reserves Cost Estimate Table, adopting the straight-line accounting method to ensure the availability of funds at the end of the replaced element's EUL, beyond the evaluation period of this assessment.</p>
Plumbing Systems	<p>According to available information and observations, supply piping is noted to include cross-linked polyethylene (PEX), and waste and vent piping is Polyvinyl Chloride (PVC).</p> <p>The plumbing systems appeared to be in good condition. The water pressure, quantity of hot and cold water, and drainagewere reported to be adequate.</p> <p>Plumbing components have EULs between 15 and 45 years. As such, an annual budget for component upgrades and replacements is recommended during the evaluation period. Funds have been spread throughout the Replacement Reserves Cost Estimate Table, adopting the straight-line accounting method to ensure the availability of funds at the end of the replaced element's EUL, beyond the evaluation period of this assessment.</p>

VIEW OF HVAC EQUIPMENT

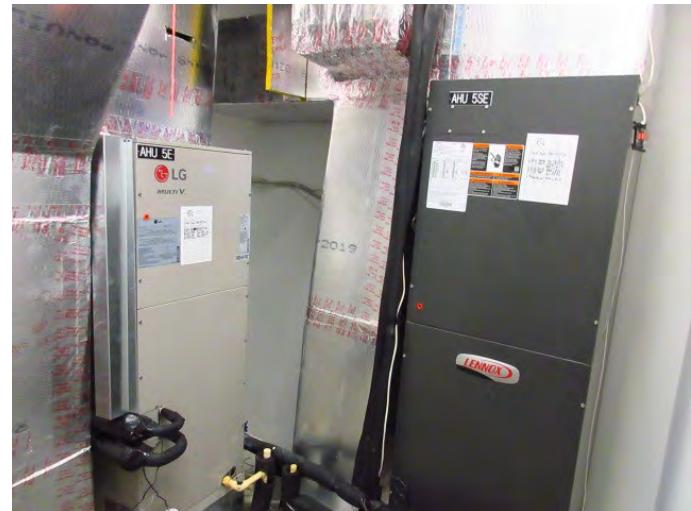
PHOTO 17

VIEW OF HVAC EQUIPMENT

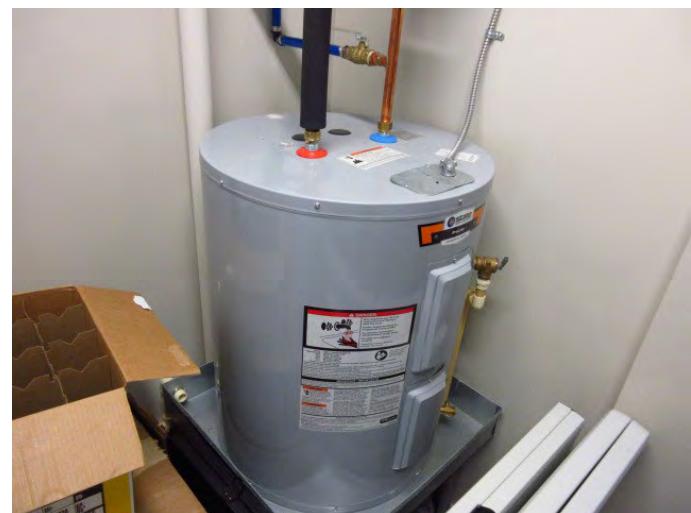
PHOTO 18

VIEW OF DOMESTIC WATER HEATER

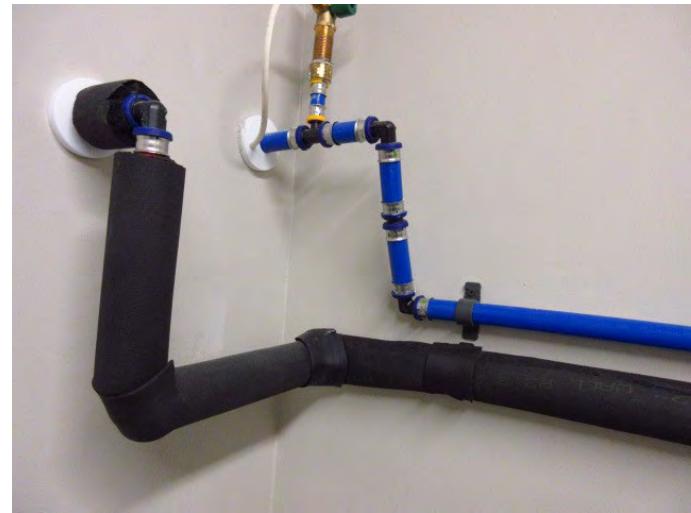
PHOTO 19

VIEW OF DOMESTIC WATER PIPING

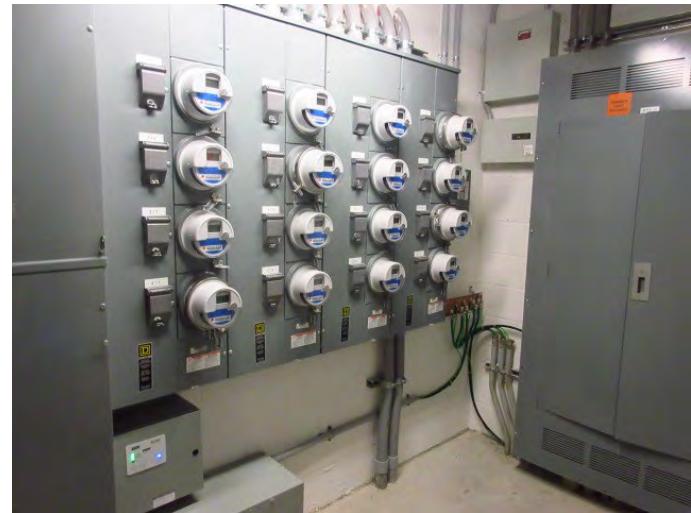
PHOTO 20

VIEW OF ELECTRICAL EQUIPMENT

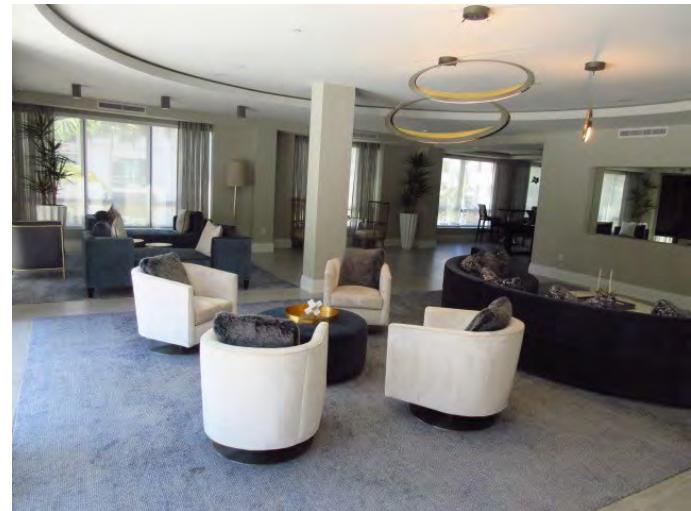
PHOTO 21

Item	Description/Observations/Comments
Tenant Spaces	Areas within the interior of the resident units are the responsibility of the individual condominium unit owner.
Common Areas	<p>The common area finishes consist of concrete flooring, tile, CMU walls, concrete ceiling, and painted gypsum-board walls and ceiling. Common area furnishings are residential grade.</p> <p>The interior common area finishes, furnishing, and equipment, appeared to be in good condition. Funds for common area finishes and gym equipment replacement have been allocated throughout the reserve period, adopting the straight-line accounting method to ensure the availability of funds at the end of the element's EUL, beyond the evaluation period of this assessment.</p>

VIEW OF COMMON AREA INTERIOR

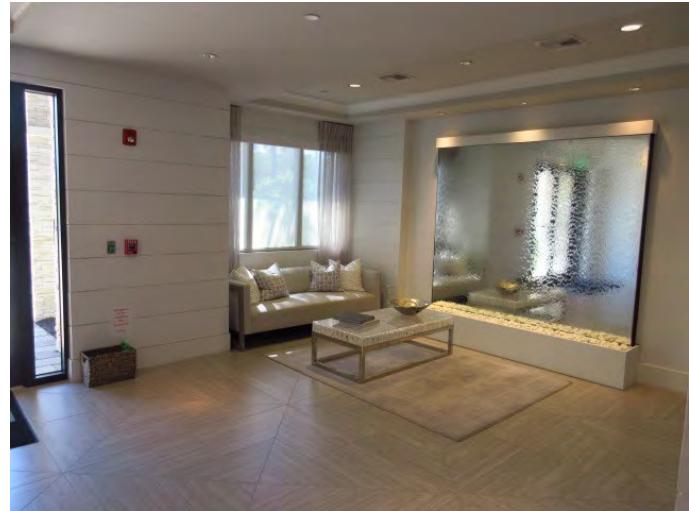
PHOTO 22

VIEW OF COMMON AREA INTERIOR

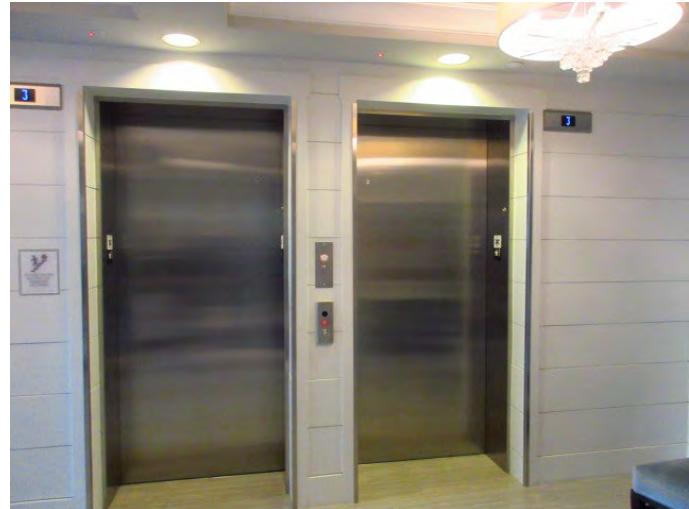
PHOTO 23

VIEW OF ELEVATOR LOBBY

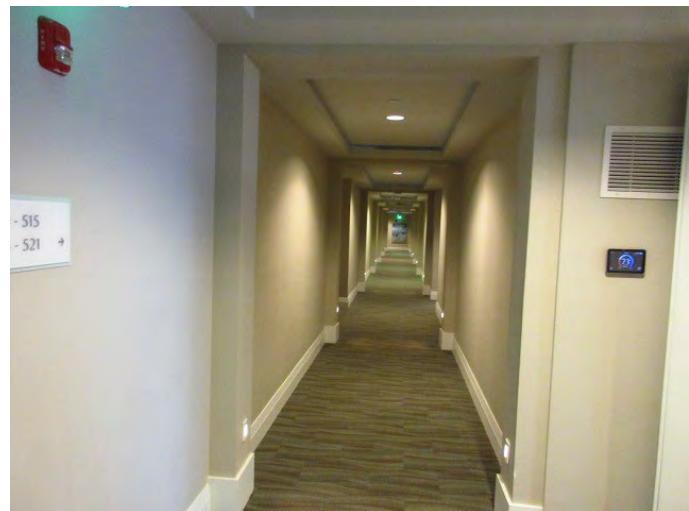
PHOTO 24

VIEW OF COMMON AREA HALLWAY

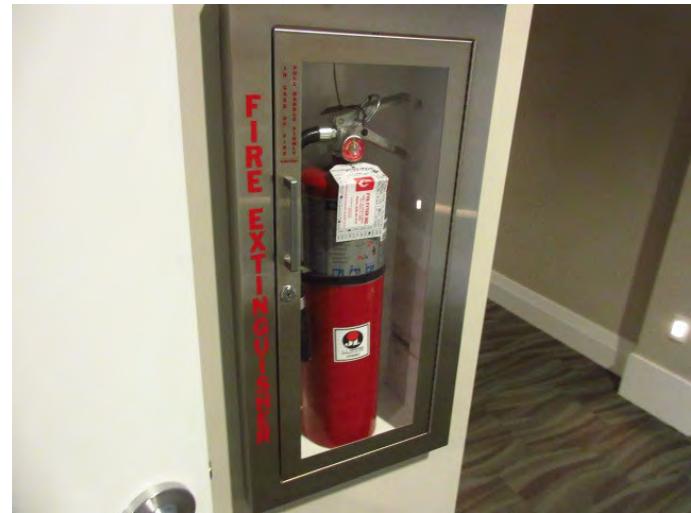
PHOTO 25

VIEW OF FIRE EXTINGUISHER

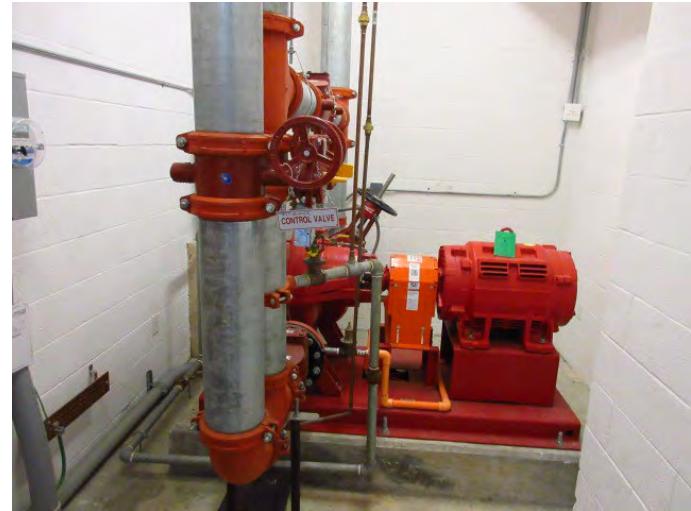
PHOTO 26

VIEW OF FIRE SUPPRESSION SYSTEM

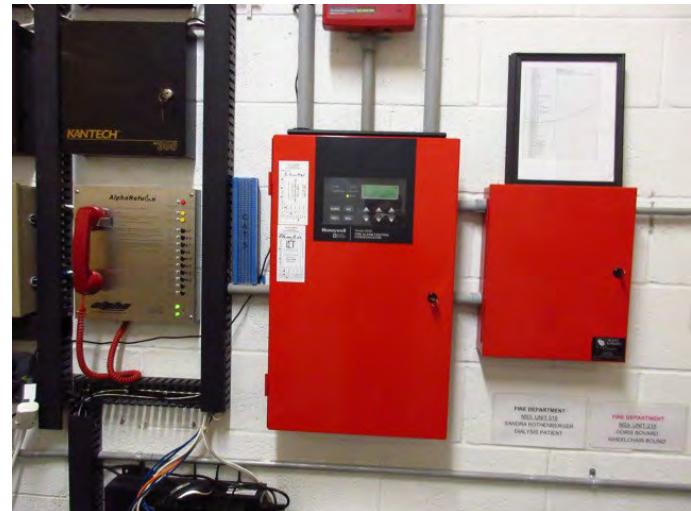
PHOTO 27

VIEW OF CENTRAL ALARM PANEL
